TECHNICAL REPORT

LET'S LOOK AT THE TOYOTA HILUX

Let's look at the Toyota Hilux

Revised Steel GMA (MIG) Welding Qualification Test

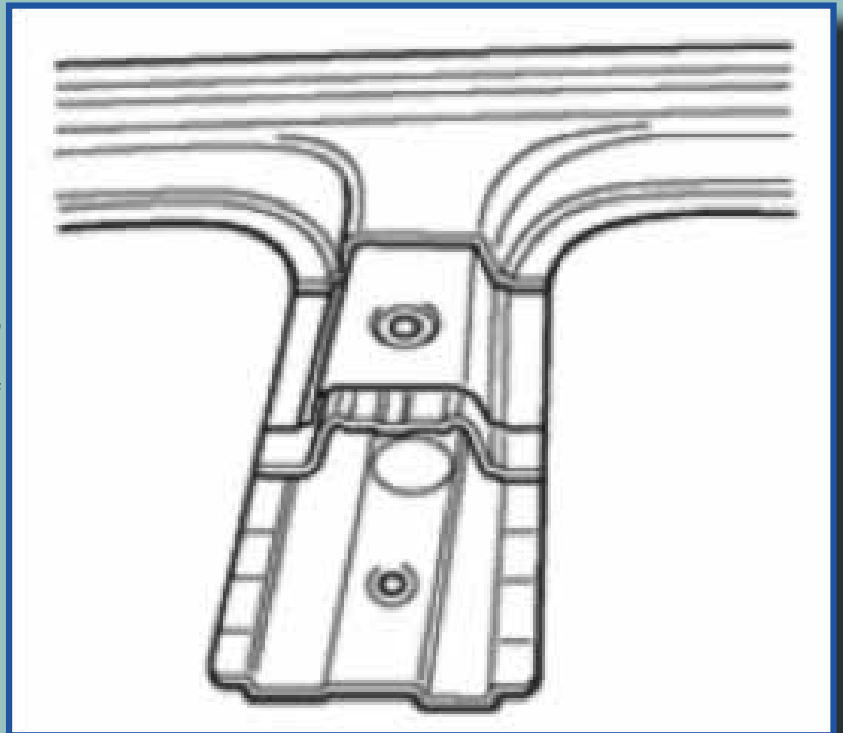
Fig 1. B Pillar reinforcement upper joint

Fig 1: shows the upper staggered joint for sectioning the double cab B Pillar. The repair manual also states that Toyota prohibits the use of the heat repair method when repairing collision damage and that parts that are kinked should be replaced.

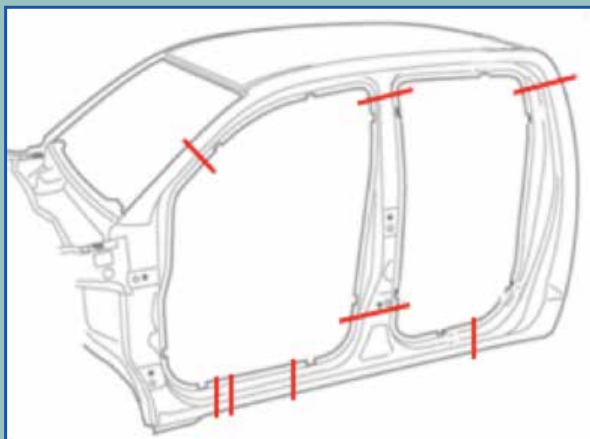
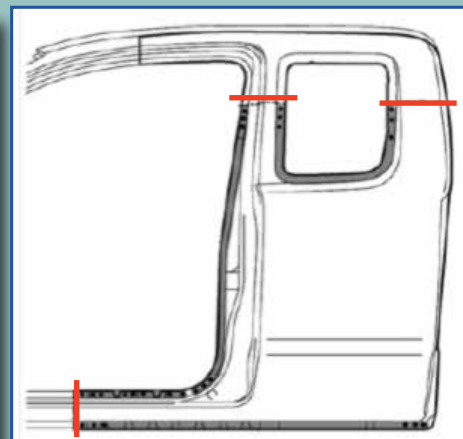
Fig 2 and 3. Outer panel cut options

Fig 2 and 3: show the cut options available for the double and extended cab outer side panels; these cut locations are similar for all three models of cab. Note!! This illustration is only an example; you will need the full specifications for accurate cut measurements.

Because the side panel replacement parts are cut from the full side aperture not all parts required for specific repair situations are covered in the repair specifications. An example of this is if the vehicle has rolled over and just the upper cant rail requires replacing. For these types of repair you will need to purchase the A Pillar and the Rear Quarter Pillar, these parts have the portion of cant rail panel you require. You need to weld these panels together and then use the sectioning joint location shown for the upper A Pillar and Rear Quarter Panel.

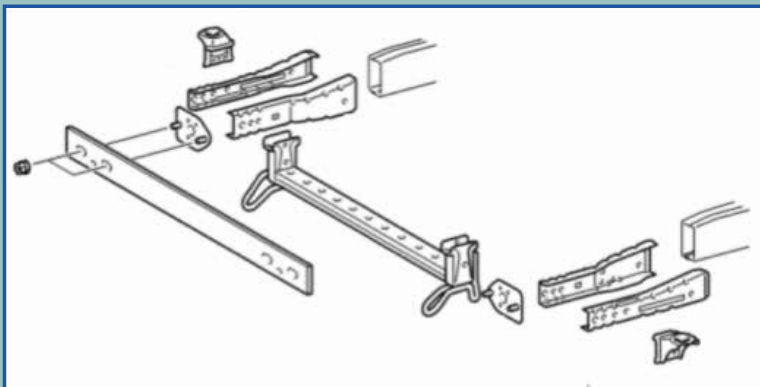
Fig. 3; Front chassis rail replacement parts

Industry is always asking for chassis repair information for the Hilux. Toyota do have some good information for the front section of the Hilux chassis and mounting brackets, however there are no repair methods given for any other part of the chassis, perhaps because a higher strength steel is used for the remainder of the rail. Remember, Toyota don't want heat used for straightening. The front chassis section shown in Fig 3 is available as a part and comes with 18 pages of detailed cutting and welding specifications of how this should be done. The rails can be sectioned in three different locations depending on the extent of damage, see Fig 4 (Reference to this information can be found in Toyota Technical Bulletin 08/03)

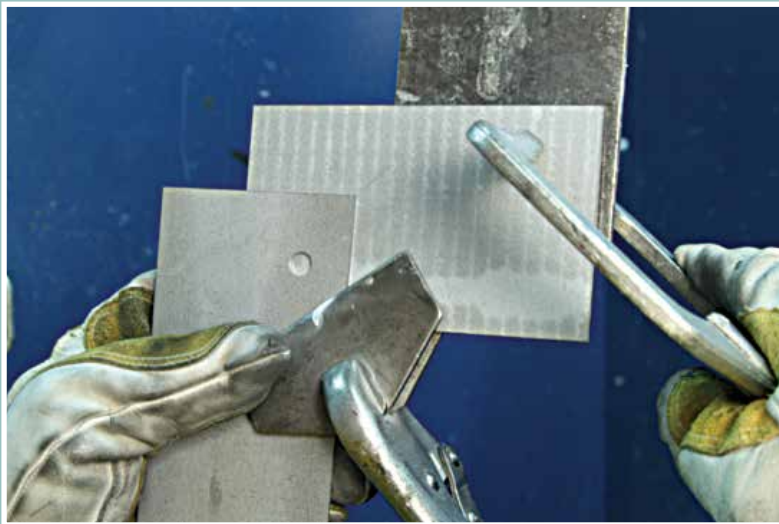
The revised test was released for introduction in early 2013. It features ten welds made on steel coupons in two thicknesses aimed at representing steel thicknesses on today's vehicles (see image below).

Based on a survey of some of the top-selling vehicles, the two thicknesses selected are 22 gauge and 16 gauge zinc-coated steel. 22 gauge coated steel varies in thickness between 0.68 – 0.81 mm. 16 gauge zinc-coated steel varies in thickness between 1.4 – 1.6 mm. The original test coupons were a single thickness, 18 gauge steel. The two thicknesses selected not only represent the steel thicknesses found on current vehicles, but we feel the revised test requires a broader range of technician welding ability and verifies that the technician has the skills required to weld advanced structures.

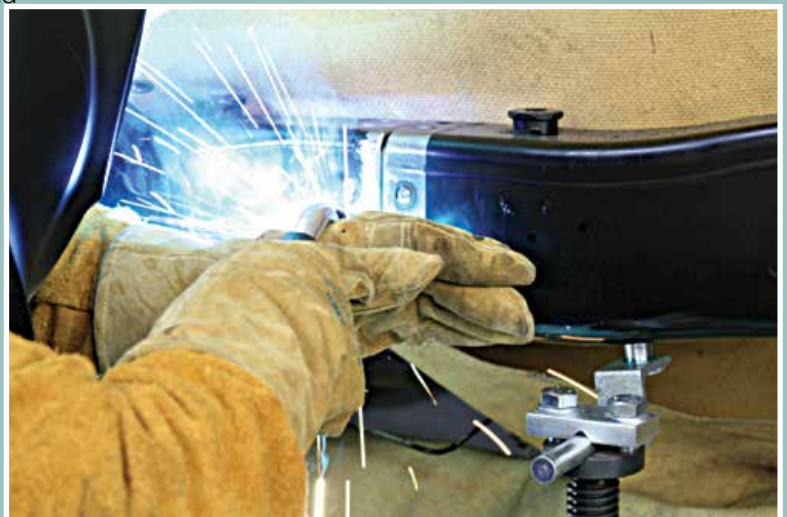
There's also a "thick-to-thick" plug weld (16 gauge to 16 gauge) in the vertical position. The plug weld is made in an 8 mm hole punched out of the top coupon. This represents, for example, plug welds made into a butt joint with backing insert when sectioning a rail (see image below).

For the destructive test on these two welds, I-CAR requires a tearout hole in the bottom, base metal coupon at least 5 mm, but no greater than 10 mm. The I-CAR Steel GMA (MIG) Welding Qualification Test gauge can be used to measure the tearout hole. A tearout hole close to the size of the plug weld itself signifies a strong plug weld, but too large of a tearout indicates too much heat.

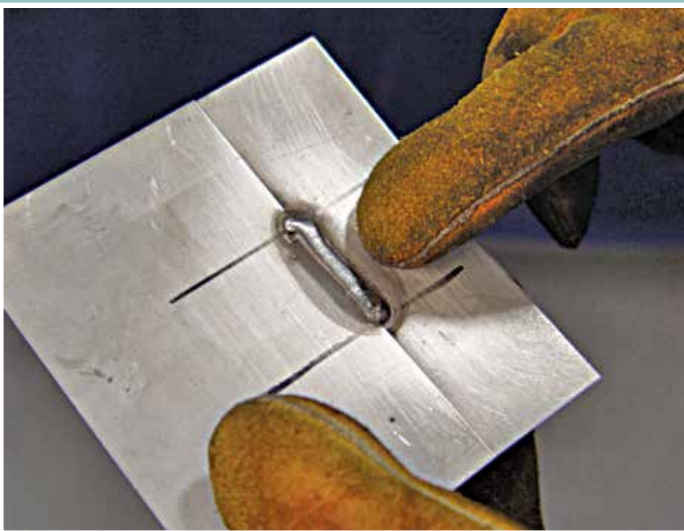
In addition to plug welds, there are open butt joints, butt joints with backing, and fillet, or lap welds required in the qualification test. All of these welds are done on the same thickness materials (see image below).

There's a vertical open butt joint using two thin coupons, which represents a common joint required on pillars and rocker panels on Toyota vehicles, for example. There's an overhead butt joint with backing using three thick coupons. This represents, for example, a common joint when sectioning a front lower rail on a Chrysler vehicle. There are two thin-to-thin fillet welds required, both a vertical and overhead. These represent the joints where an exterior panel is lapped over another exterior panel.

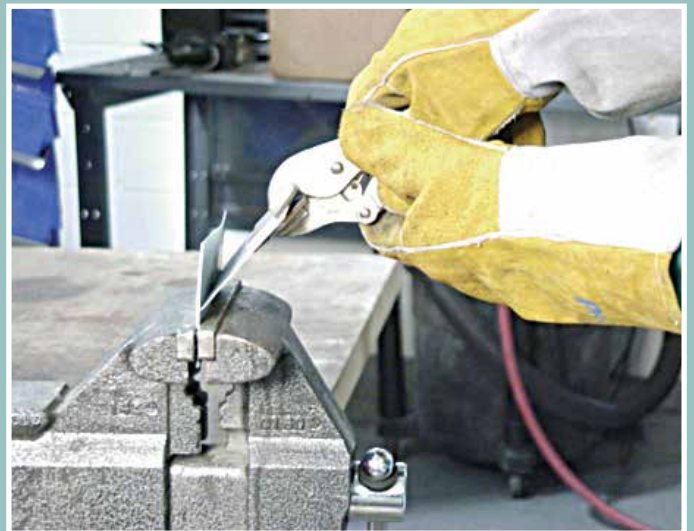
As has been the case for several years, an I-CAR test administrator will administer the test at your repair facility using your own welding equipment. This helps ensure you are familiar with the equipment and surroundings. Also, you will receive tips on maintenance and tuning the welder for a successful weld. The test administrator provides the test coupons and a weld clamp stand for making the welds in the vertical and overhead positions. A check-off form, given to the repair facility prior to the test day, ensures that the facility has the right equipment, materials and destruction testing of welds has been carried out for the test. (See image below of destruction testing a weld).
